# ASSESSMENT AND REHABILITATION OF A HERITAGE MASONRY BUILDING IN PIRAEUS, GREECE

## ABSTRACT

This paper presents the assessment, rehabilitation and strengthening of a heritage masonry structure in Piraeus, Greece. The two-storey structure was constructed around 1900 and is used as a student restaurant at the University of Piraeus. The geometry is complex for a masonry structure and, furthermore, the masonry walls have been prestressed via wrought-iron tendons. The floors are constructed with the jack-arch method, supported by steel girders. This study was particularly challenging because of uncertainties regarding the properties of the structural materials and alterations to the live loads related to the change in the use of the building. Because the building has been declared a protected monument by the Greek State, the primary concern of the suggested retrofit was the preservation of its architectural and historical value. Thus, additional issues arose in the effort to minimize interventions. Extensive numerical simulations are presented and an extended discussion is included regarding the appropriate rehabilitation and strengthening techniques in order to satisfy both the bas

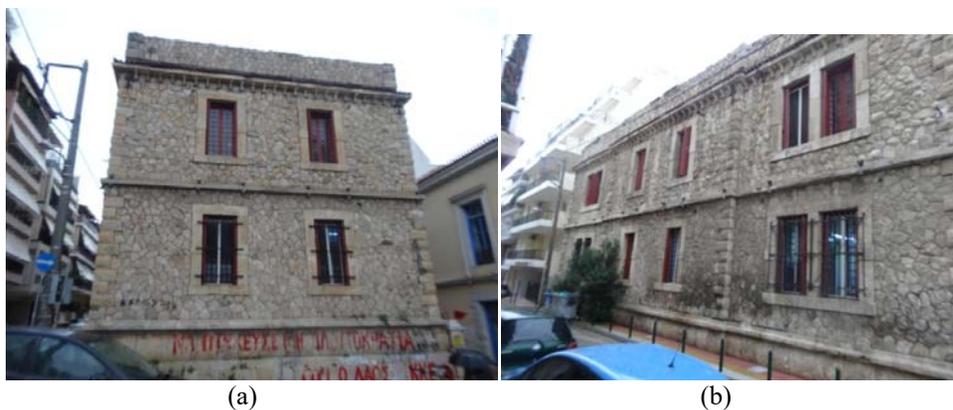
Figure 1: Exterior façades of building. (a) Northern; (b) Western.

As shown in Fig. 1, large limestones have been used at the corners where large stress concentrations are expected. Every corner stone is flanked by two others perpendicular to it. This arrangement of corner stones plays a fundamental role in ensuring an effective connection between perpendicular walls. Thus, this construction technique in historical masonry buildings contributes significantly to their monolithic response.

unreinforced masonry parapet in the perimeter of the top level. Photographs of the exterior of the building (façade) are shown in Fig. 1, while plan views of the ground and first floors are presented in Fig. 2.

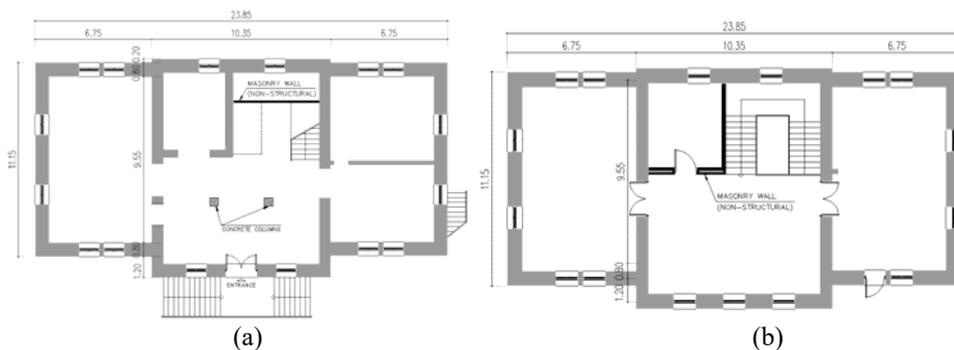
Figure 2: Plan views: (a) ground floor; (b) first floor.

To relieve walls of high out-of-plane bending values, it is desirable that they be as short as possible lengthwise. Fortunately, as can be seen from the structural layout (Fig. 2), the walls on the long dimension of the examined building intersect with the two interior walls at two points. Moreover, the interior walls are sufficiently thick and long and without many openings. Thus, they can provide lateral support to the walls on the long dimension. Put simply, the transverse walls divide the unsupported length of the walls on the long dimension into three parts, thereby reducing their out-of-plane displacements. This, combined with the fact that the composite slab at the top of the ground floor as well as the steel ties at the top of

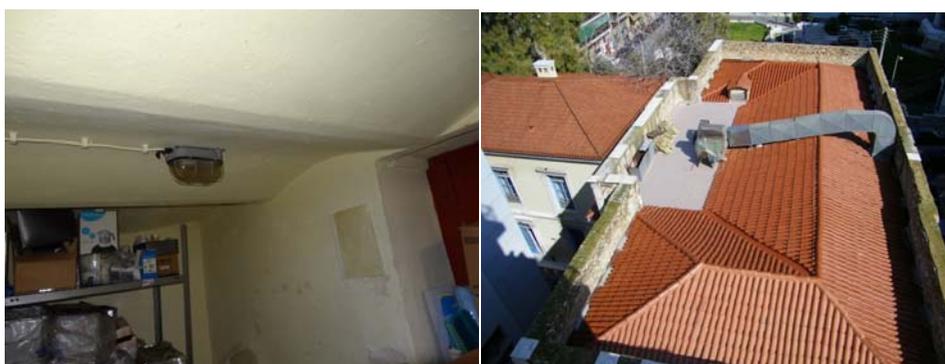
Regarding the slab of the ground floor, it comprises a jack-arch system (Fig. 3(a)), while for the roof of the first floor the same composite system is used only in the part not covered by the timber roof, as shown in Fig. 3(b).

Figure 3: Structural characteristics. (a) Configuration of jack-arch slab; (b) Location of roof where jack-arch slab is present.

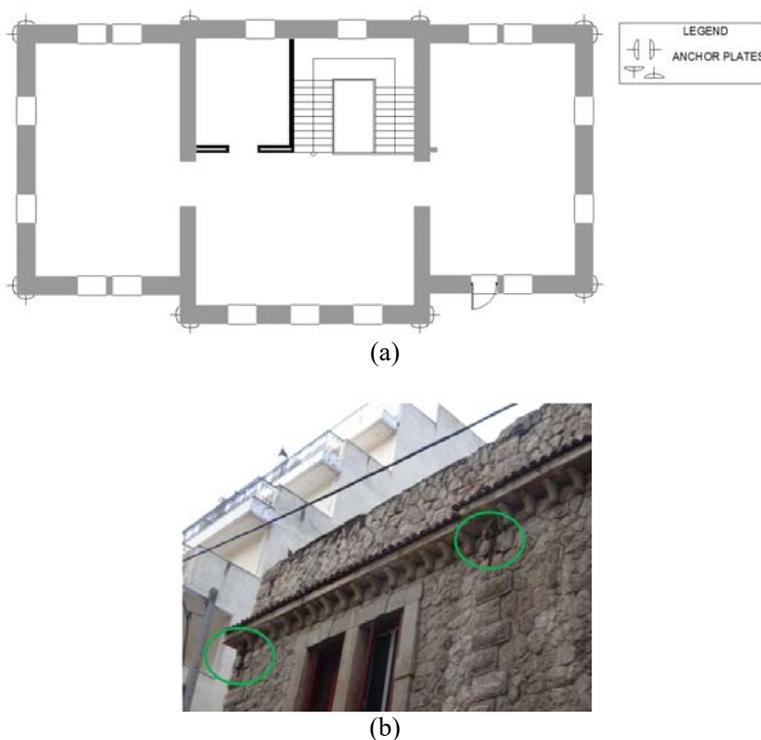
Diaphragm action for the roof of the second floor is provided partially by the use of wrought-iron tie rods running along all longitudinal and transverse walls (Fig. 4(a)) and anchored in steel ties like those encircled in green in Fig. 4(b). The use of such steel ties in historical masonry structures can increase the load capacity of the participating walls [12]. It is also highlighted in Corradi et al. [13] that strengthening with steel cords significantly increases the compression and shear strength of the walls. However, as is stated in Mora-Gómez [12] and Calderini et al. [14], increasing the pre-tension in the iron tie rods does not increase the collapse load by much.

Figure 4: System of wrought-iron tie rods. (a) Locations of anchor plates on exterior walls of first floor; (b) Configuration of anchor plates (encircled in green).

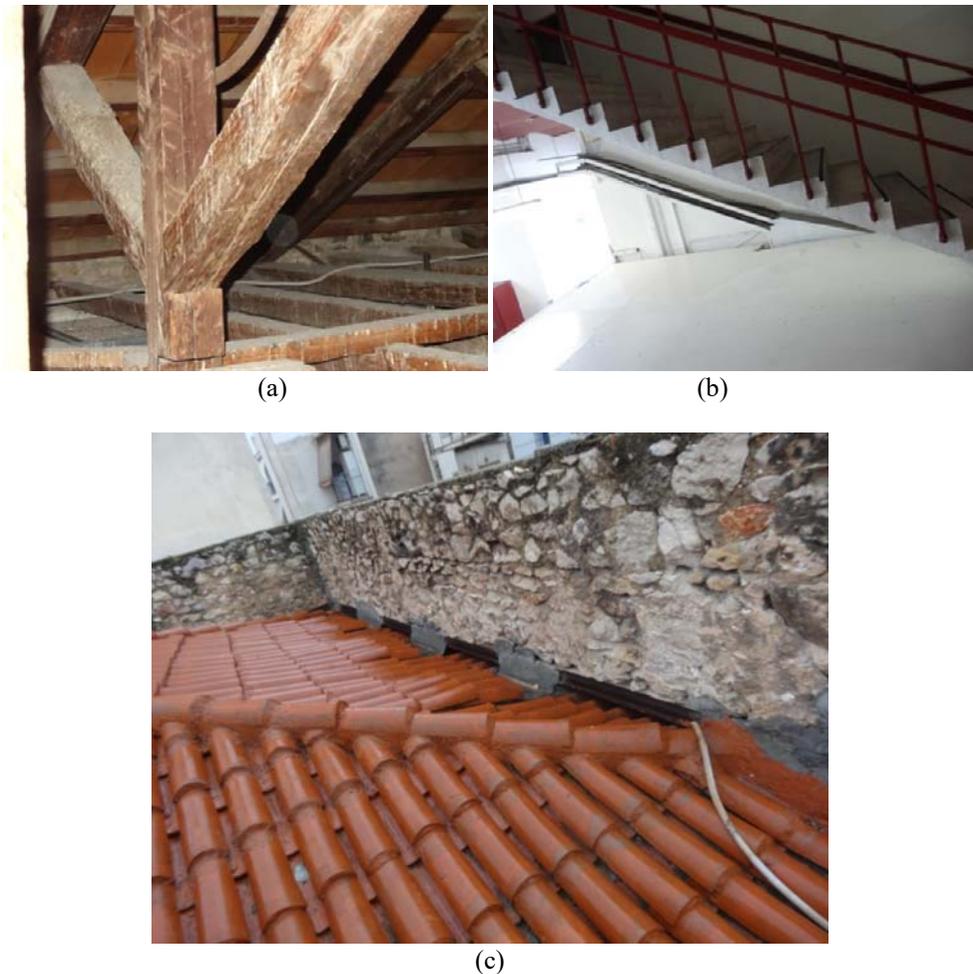
- indications of corrosion are visible on the structural members of the timber roof;
- cracks on the stairs slab of the internal staircase;
- an unreinforced masonry parapet in the perimeter of the top level is prone to out-of-plane rocking behaviour;
- detachment of the coating at several parts of the building due to moisture and oxidation of the steel profiles supporting the jacked arches.

Figure 5: Building's pathology. (a) Typical truss having experienced corrosion by rainwater; (b) Statically insufficient thickness of stairs slab; (c) Masonry parapet in perimeter of top level. Restoration proposal requires its removal.

The timber roof is significantly damaged. Although the structural members of the trusses do not appear to have experienced failure, some of the trusses exhibit excessive corrosion (Fig. 5(a)) due to rainwater that was not blocked effectively by the roof tiles. Furthermore, the roof purlins have suffered large deflections.

Changing the building from a house to a restaurant resulted inevitably in the structure having to withstand new, significantly increased live loads. The appearance of cracking on the internal staircase (Fig. 5(b)) can be attributed to this fact and to the thinness of the stair slab (around 5 cm) for the required cantilever action.

Additionally, the unreinforced masonry parapet in the perimeter of the top level (Fig. 5(c)) poses a threat to passers-by in case of a seismic event because it is insufficiently supported on steel section profiles.

As in most cases of retrofitting historical buildings [26], the strengthening methods should not alter the traditional architectural characteristics of the building. In particular, because an effective repair of the timber roof would be rather unfeasible or at least cost-ineffective, the design team decided on removing the roof completely and constructing a new one. The new timber roof will have a similar configuration to that of the existing one and will be adequately connected to the masonry walls so that rigid diaphragm action can be achieved.

Moreover, to relieve the internal staircase from its cracking, the external bonding of the two walls that are supporting it is proposed through textile-reinforced mortar (TRM). The advantages of this strengthening method over similar ones are studied extensively in Papanicolaou et al. [27] and Tetta et al. [28], where TRM is compared with fibre-reinforced polymer (FRP) as the strengthening material.

Stainless-steel sections are also suggested as a means of interconnecting the walls of the parapet. This strengthening method is expected to contribute significantly to making potential out-of-plane rocking behaviour of the parapet unlikely.

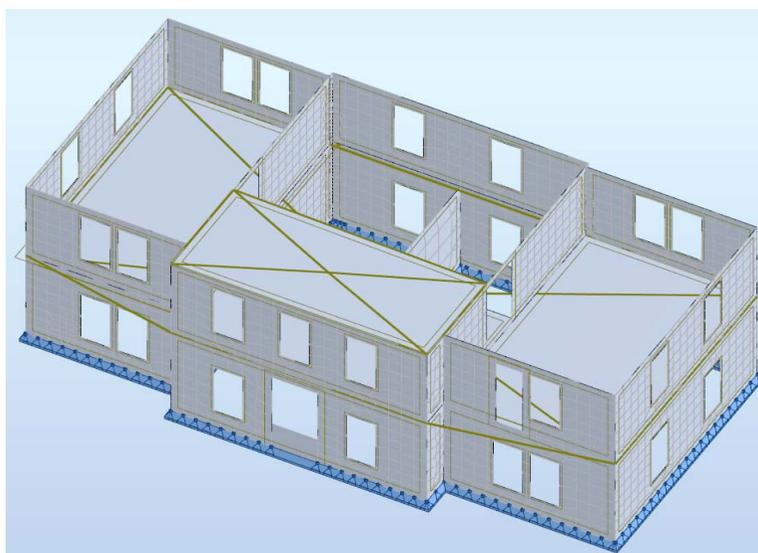
When studying the response of masonry buildings, using shell elements is the most effective way to model the in- and out-of-plane behaviour of walls because of the ability of shell elements to capture flexural deformations and membrane forces accurately. In this case study, four-node shell elements were used with thicknesses of 0.25–0.80 m according to the actual thicknesses of the exterior and interior walls of the building. A convergence analysis was necessary to define the finite element size. Pinned connections were assumed for the boundary conditions of the mathematical model because no failures indicating foundation or soil failure were recorded during the site investigation. Note that for reasons of simplicity, the effect of the wrought-iron tie rods was neglected. Additionally, the composite slab was not considered explicitly in the finite-element model. More specifically, an equivalent thickness of reinforced concrete slab was used, taking into account the material properties of the jack-arch system (i.e. the properties of the concrete and steel sections). Given that the jack-arch system is considered sufficient to provide diaphragm action, the rigid-diaphragm option in the software was used only where this system is present (Fig. 6).

The timber roof was not included at all in the finite-element model because practically its connection to the masonry walls is almost impossible to achieve. This is due to the fact that the huge lateral stiffness of the masonry walls makes the in-plane stiffness of the floor insignificant. However, typical lattice trusses of the roof were modelled and then solved under the characteristic imposed snow and wind loads acting on them. The reactions of each load case were then transferred to the respective node of the three-dimensional model (Fig. 6).

Figure 6: Finite-element model of structure.

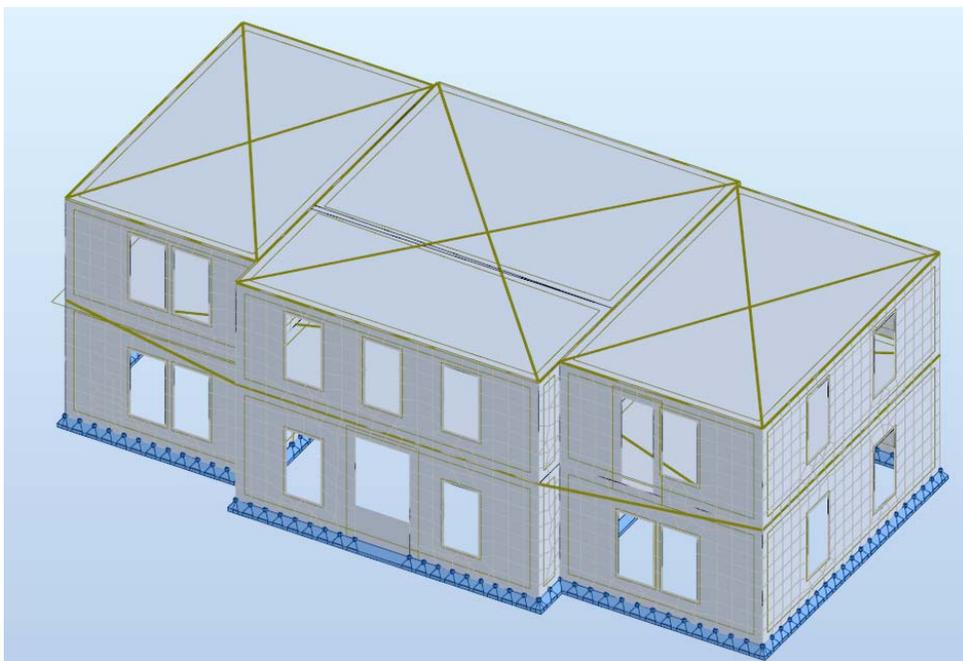
Note that of all the aforementioned strengthening techniques, only the one involving adding a rigid diaphragm at the top of the first floor was considered in the modified mathematical model (Fig. 7). The reason for this is that the other restoration measures are unlikely to have a significant effect on the global behaviour of the building. Note also that because the configuration of the new timber roof will follow closely that of the existing one, all the loads transferred from the timber trusses to the masonry walls will be equal to the initial ones.

Figure 7: Finite-element model in Robot Structural Analysis software after strengthening proposal.

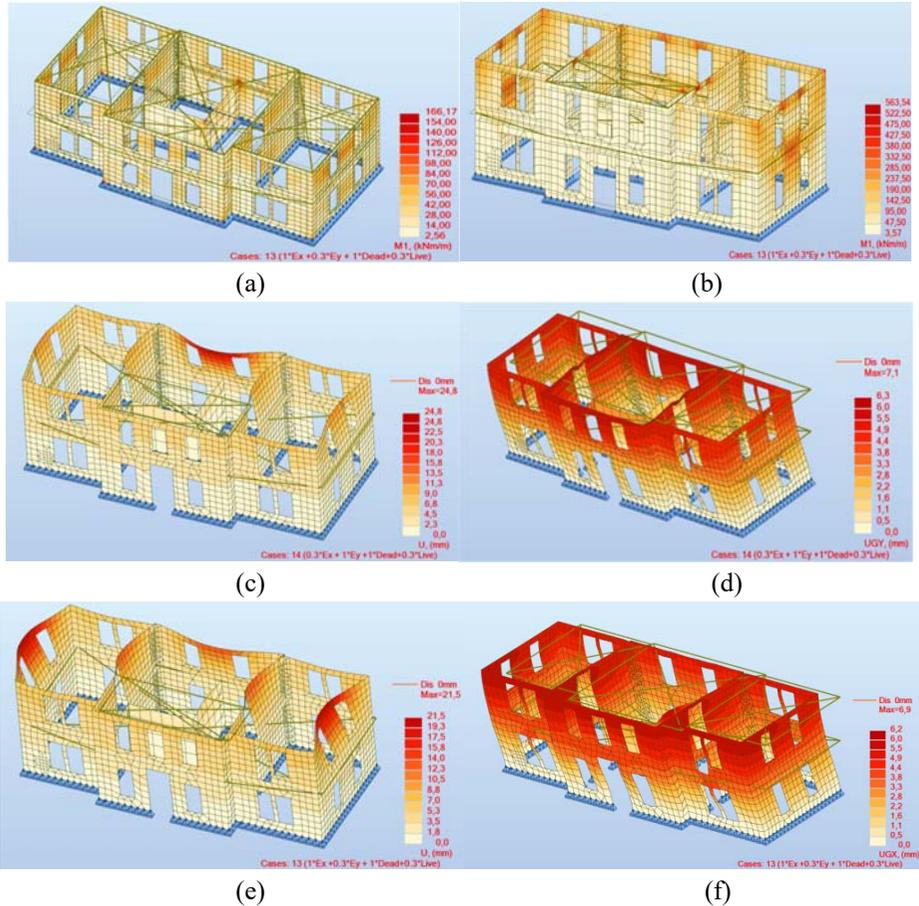
In Fig. 8, the results for the bending moments and the displacements in both main directions are compared for the initial structure and the strengthened one. In the absence of a diaphragm at the top level, the walls of the first floor behave as cantilevers in practice. Consequently, while the bending moments and displacements have low values within the walls of the ground floor, they increase freely from the base to the top of the first floor. In the strengthened model, shear forces, displacements and bending moments were limited to low values.

Figure 8: Indicative analysis results after strengthening proposal. (a), (b) Principal bending moment  $M1$  (kN·m/m); (c), (d) Global displacements in X direction (mm); (e), (f) Global displacements in Y direction (mm).

Table 1 allows comparison of various results obtained from analysing the existing structure and the retrofitted one. The results refer to the maximum principal bending moment, shear force and global displacement of the structure. All values for the retrofitted section satisfied the design checks [25]. Note also that the modal frequencies of the retrofitted building are higher than those of the existing building owing to an increase in stiffness associated with the presence of floor diaphragms.
